THE TOWN OF ALBION

What: REQUEST FOR INFORMAL PROPOSALS (RFP) to PURCHASE REAL PROPERTY

Where: Town-owned building located at 110 S. Orange Street, Albion IN 46701

Property Inspection Report

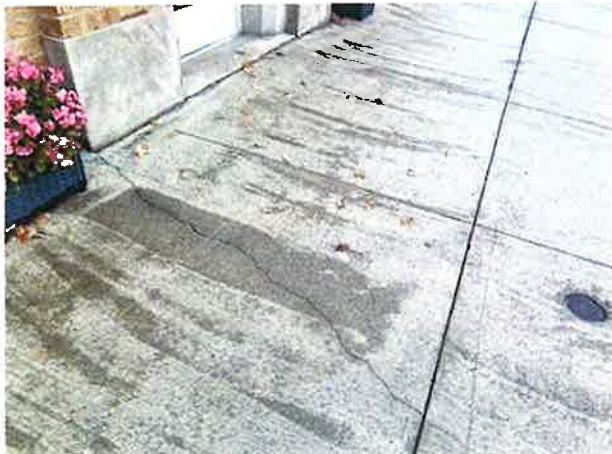
Photo 3-1

3) Repair/Maintain - Cracks, holes, settlement, heaving and/or deterioration were found in sidewalks and/or patios. Recommend that qualified contractor repair as necessary.

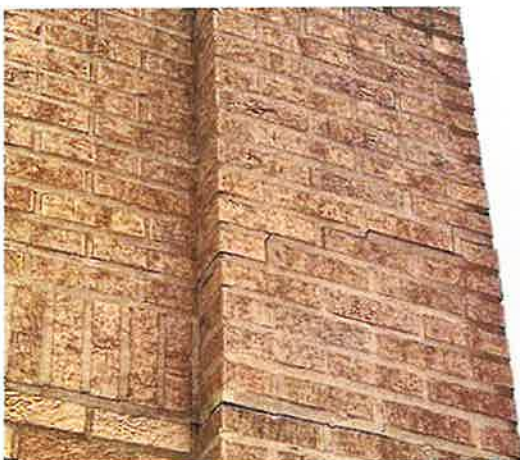
Photo 4-1

4) Repair/Replace, Evaluate - The masonry (brick or stone) veneer was deteriorated or damaged in many areas. Where cracks or openings are exposed, water may enter the wall structure causing mold, fungal growth and structural damage. This is a conducive condition for wood-destroying organisms. Recommend that a qualified contractor repair as necessary. For example, by repointing mortar or replacing broken or missing masonry.

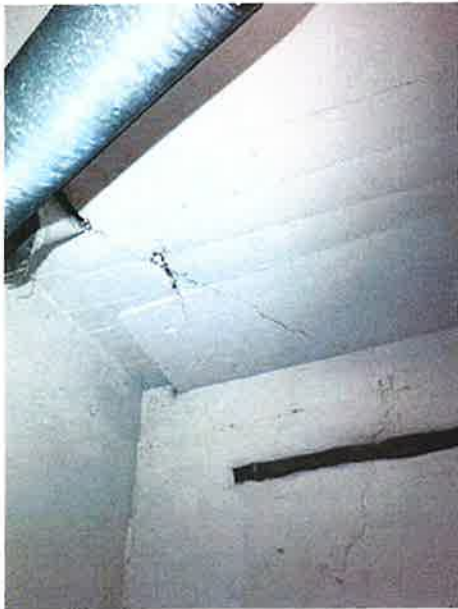
Photo 5-1

5) **Repair/Maintain, Evaluate, Monitor** - Moderate cracks (1/8 inch - 3/4 inch) were found in the foundation. Cracks should be monitored for future deterioration, especially if water intrusion occurs through them.

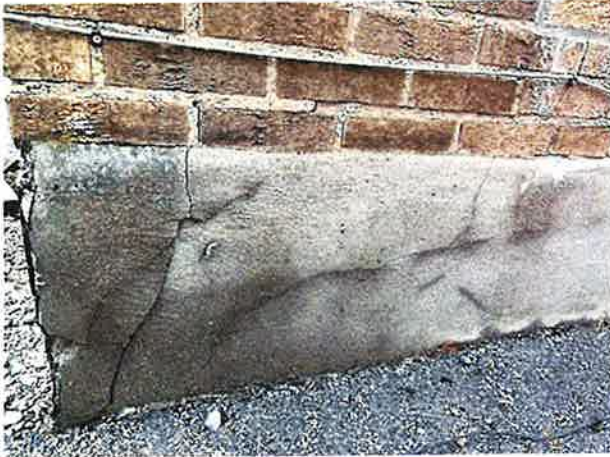
Photo 6-1

6) **Repair/Maintain, Evaluate** - The parging (decorative coating) on one or more foundation walls was damaged or deteriorated. A qualified person should evaluate and make repairs if necessary to ensure this is in fact parge coat and not foundation cracks.

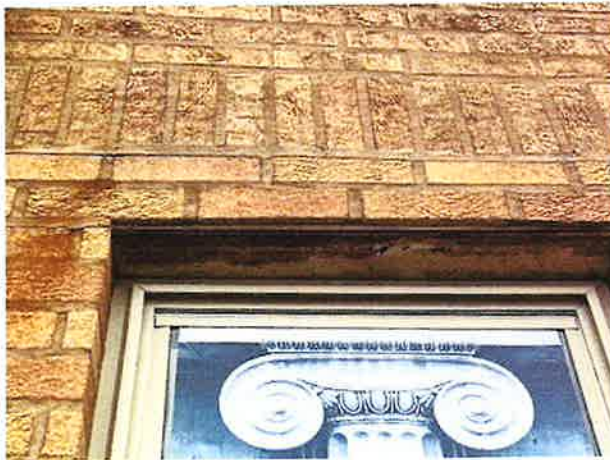
Photo 7-1

7) Repair/Maintain, Monitor - Observed rust/corrosion on the lintel above the opening. The corrosion may weaken the structural integrity over time, leading to potential issues with load support. Recommend cleaning and treating the lintel with rust-inhibiting paint, and if deterioration is extensive, consult a qualified professional for repair or replacement to prevent further degradation

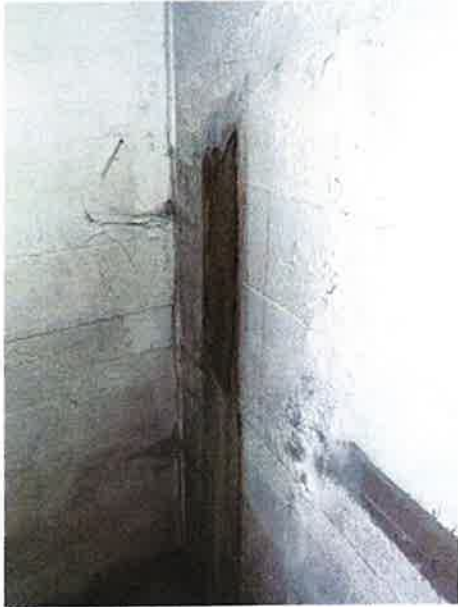
Photo 8-1

8) Evaluate - Any past repairs or patching to the foundation walls should be disclosed to the buyer. These repairs could indicate previous issues with moisture intrusion, structural concerns, or other conditions that warranted corrective action. Proper disclosure allows the buyer to assess the quality and extent of repairs and to consider any potential need for future maintenance or monitoring

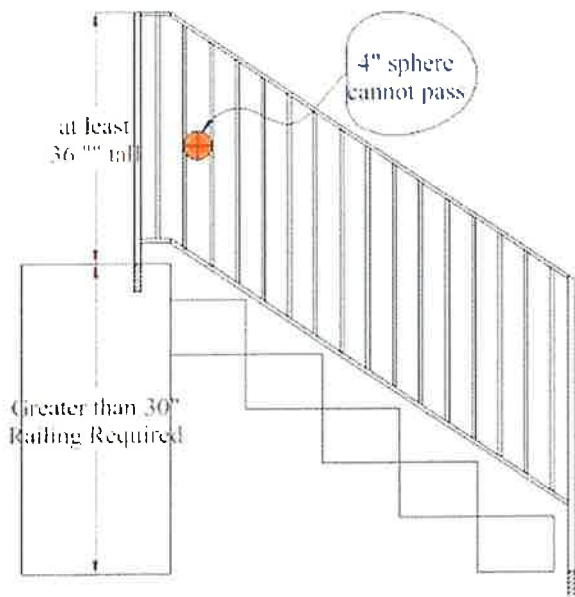
Photo 9-1

9) Safety, Repair/Replace - Guardrails at one or more locations with drop-offs higher than 30 inches were missing. This poses a fall hazard. Guardrails should be installed where walking surfaces are more than 30 inches above the surrounding grade or surfaces below. Recommend that a qualified contractor install guardrails where missing and per standard building practices.

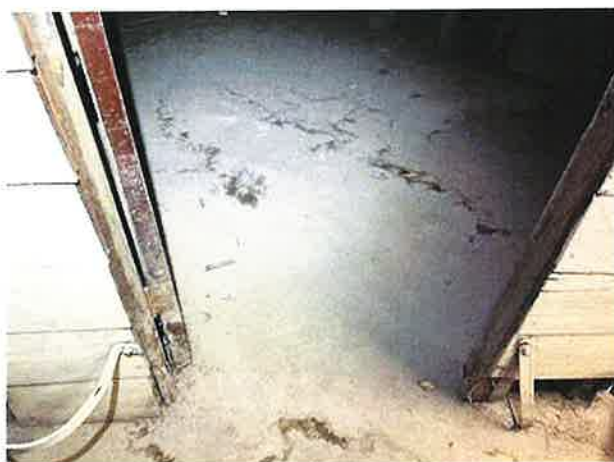
Photo 10-1

10) Repair/Replace, Evaluate - Standing water or evidence of past water intrusion was found in many sections of the basement. Recommend that a qualified contractor who specializes in drainage issues evaluate and repair as necessary.

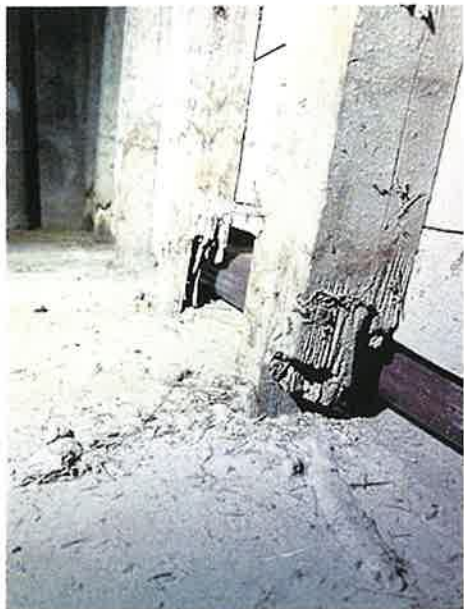
Photo 11-1

11) Repair/Replace, Evaluate - Wall is leaning and rotted. Wall should be taken down or repaired. A qualified person should evaluate and make repairs as necessary.

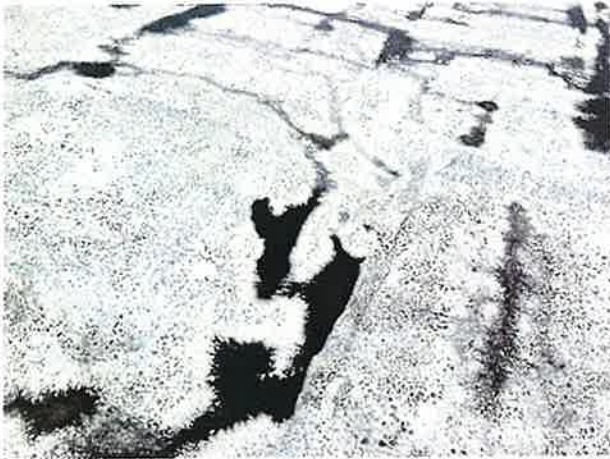
Photo 12-1

12) Repair/Replace, Evaluate - Ponding (pools of standing water) was found at one or more locations on the flat or low-slope roof surface. Even on a flat roof, water should be removed by a drainage system so that any remaining water evaporates within 48 hours after it rains. Prolonged standing water can result in roof leaks. This is a conducive condition for wood-destroying organisms. Recommend that a qualified contractor evaluate and repair as necessary to prevent ponding.

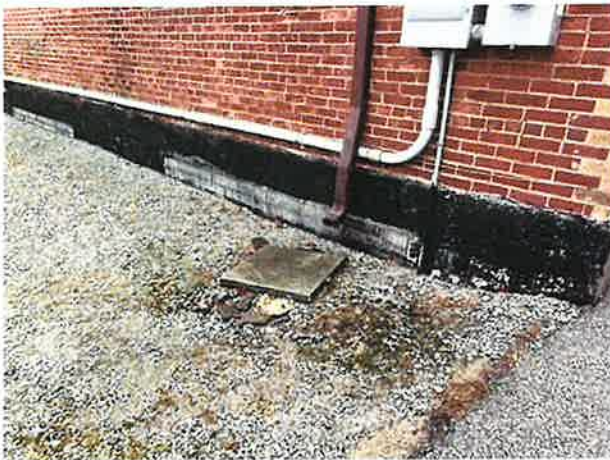
Photo 13-1

13) Repair/Replace - Extensions for downspouts were missing. Water can accumulate around the building foundation or inside crawl spaces or basements as a result. Recommend that a qualified person install, replace or repair extensions as necessary so rainwater drains away from the structure.

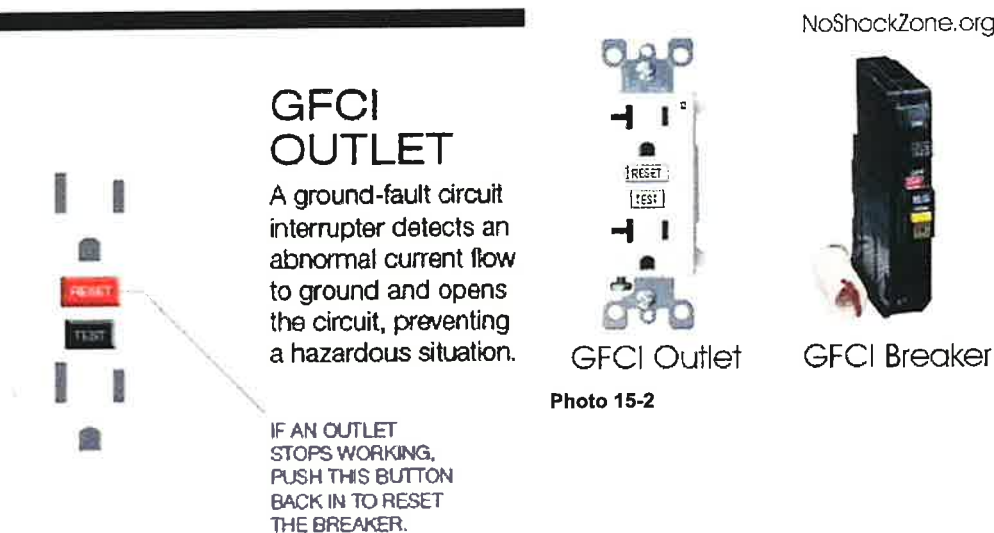
15) Safety, Repair/Replace, Evaluate - One or more electric receptacles had no visible ground fault circuit interrupter (GFCI) protection, or the inspector was unable to determine if GFCI protection was present. If not GFCI-protected, receptacles in wet areas pose a shock hazard. Recommend that a qualified electrician evaluate and install GFCI protection if necessary and per standard building practices.

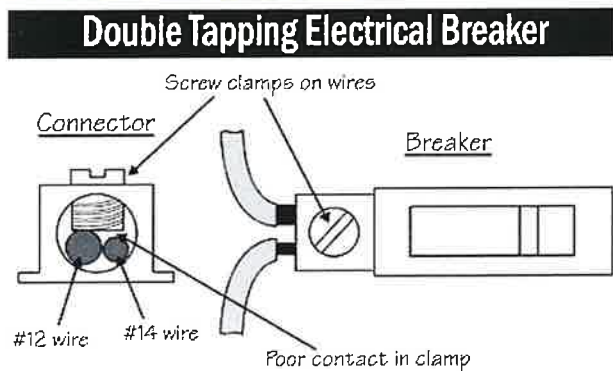
16) Safety, Repair/Replace - One or more circuit breakers in panel(s) # were "double tapped," where two or more wires were installed in the breaker's lug. Most breakers are designed for only one wire to be connected. This is a safety hazard since the lug bolt can tighten securely against one wire but leave other(s) loose. Arcing, sparks and fires can result. Recommend that a qualified electrician repair as necessary. For more information, visit:

Many breakers do not allow two wires per connection (double tap). Two wires of different wire gauge sizes (diameter) should never be used.

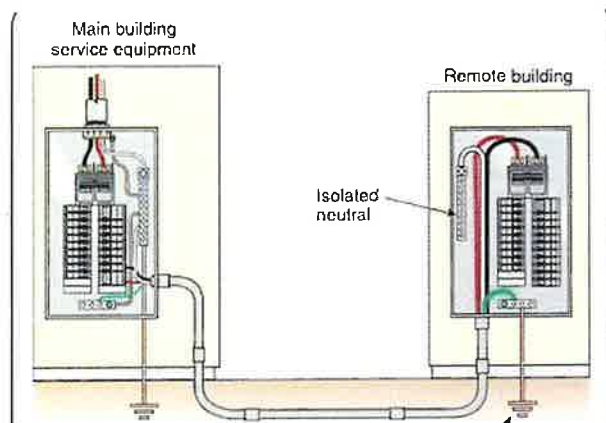
Photo 17-1

17) Safety, Repair/Replace - Neutral and equipment ground wires were bonded (connected) at sub-panel(s) # C and D. This should only occur in the main service panel, not sub-panels, and is a shock hazard. Neutral wires should be attached to a "floating" neutral bar not bonded to the panel, and grounding wires should be attached to a separate grounding bar bonded to the sub-panel. Recommend that a qualified electrician repair per standard building practices. For more information, visit:

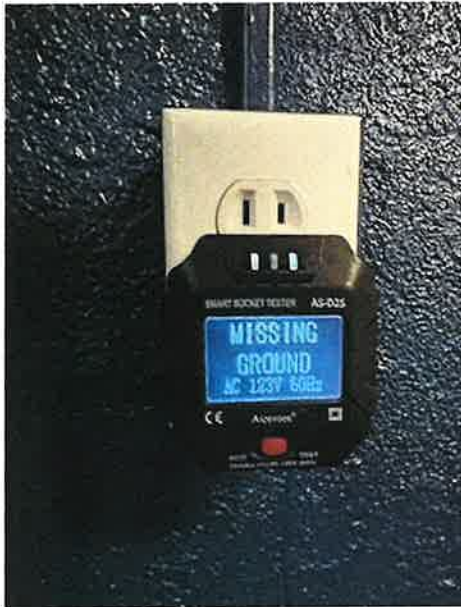
Photo 18-1

18) Safety, Repair/Replace - 3-slot electric receptacles were found with an open ground. Three-slot receptacles should have a hot, a neutral and a ground wire connected. Homeowners often install new 3-slot receptacles on older, 2-wire circuits that only have hot and neutral wires. This is a shock hazard when appliances that require a ground are used with these receptacles.

Where the electric system was installed prior to when grounded circuits were required (1960s), it is permissible to replace 3-slot receptacles with 2-slot receptacles to prevent appliances that require a ground from being plugged in to an ungrounded circuit. However, the client should be aware of this limitation when planning use for various rooms. For newer electric systems, circuits should be repaired so grounded, 3-wire cables provide power to 3-slot receptacles. Recommend that a qualified electrician repair per standard building practices.

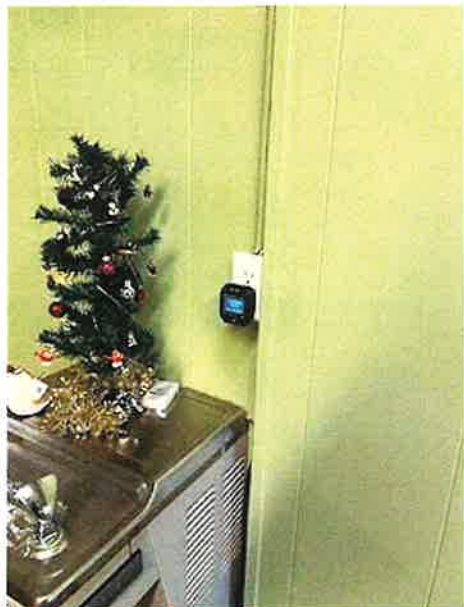
Photo 19-3

19) Safety, Repair/Replace - One or more electric receptacles had reverse-polarity wiring, where the hot and neutral wires were reversed. This is a shock hazard. Recommend that a qualified electrician repair as necessary.

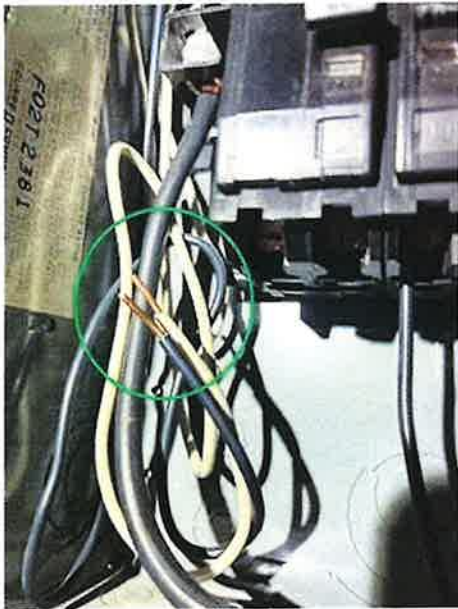
Photo 20-1

20) Safety, Repair/Maintain - One or more wires inside panel(s) #A were loose, and were not terminated. This poses a safety hazard for shock and/or fire. Recommend that a qualified electrician remove any abandoned wiring or repair as necessary. For example, by trimming wires to length and installing wire nuts.

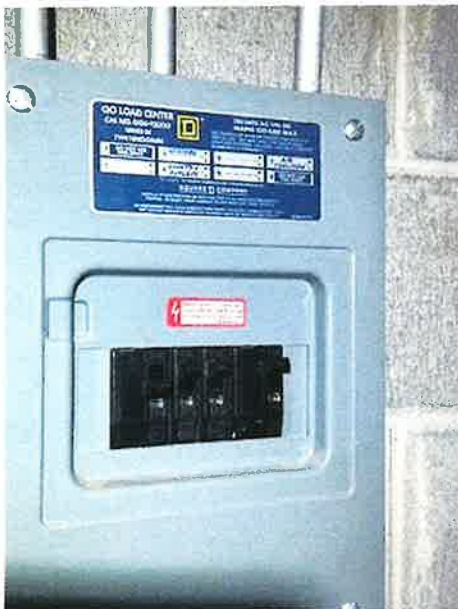
Photo 21-1

21) Repair/Maintain, Evaluate - The legend for circuit breakers or fuses in panel(s) # was missing, incomplete, illegible or confusing. This is a potential shock or fire hazard in the event of an emergency when power needs to be turned off. Recommend correcting the legend so it's accurate, complete and legible. Evaluation by a qualified electrician may be necessary.

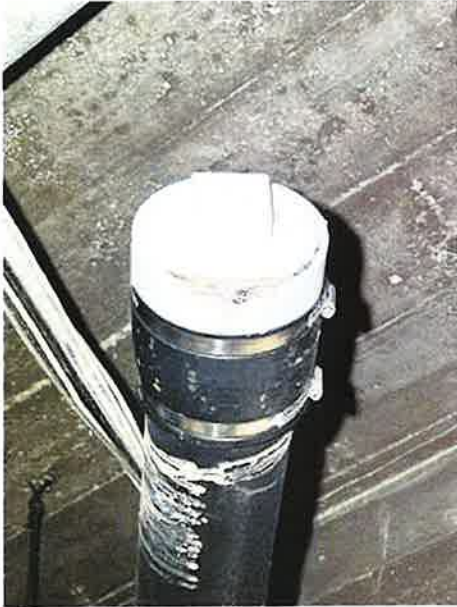
Photo 23-1

23) Repair/Replace, Evaluate, Monitor - Stains were found in one or more sections of drain and/or waste lines, but no active leaks were found near the stains. This may indicate that past leaks have occurred. Consult with the property owner about this, and either monitor these areas in the future for leaks or have a qualified plumber evaluate and repair as necessary.

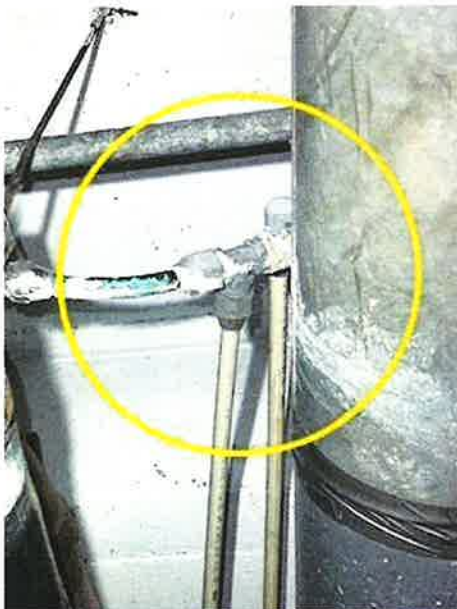
Photo 24-1

24) Repair/Replace, Evaluate - Evidence of leaks or past leaks were found in water supply pipes or fittings. A qualified plumber should evaluate and repair as necessary.

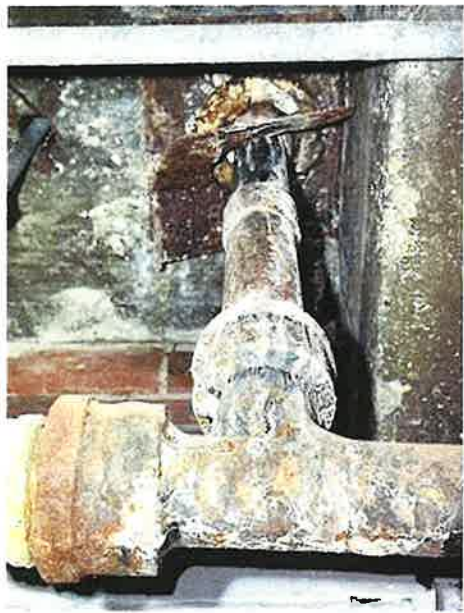
Photo 25-1

25) Repair/Replace, Evaluate - Leaks or corrosion were found in drain pipes or fittings. A qualified plumber should evaluate and repair as necessary.

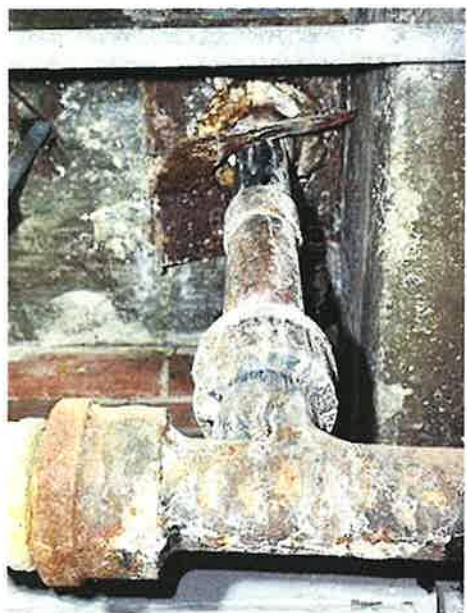
Photo 26-1

26) Repair/Replace, Evaluate - Rust or corrosion was found in some drain and/or waste pipes or fittings. This can indicate past leaks, or that leaks are likely to occur in the future. Recommend that a qualified plumber evaluate and repair as necessary.

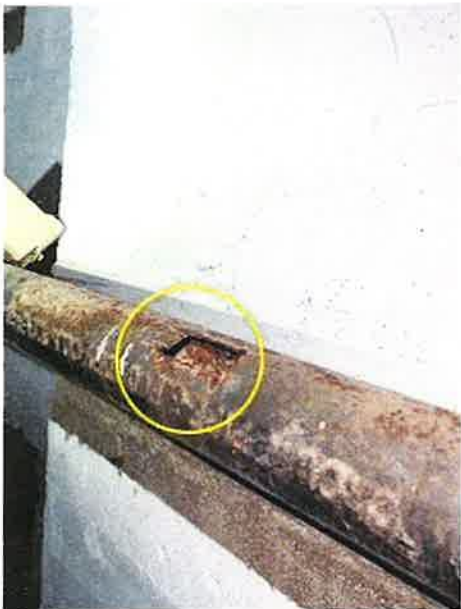
Photo 27-1

27) Repair/Replace, Evaluate - Waste line was open in one area. Sewer gases or even leaks can occur. Recommend that a qualified plumber evaluate and repair as necessary and per standard building practices.

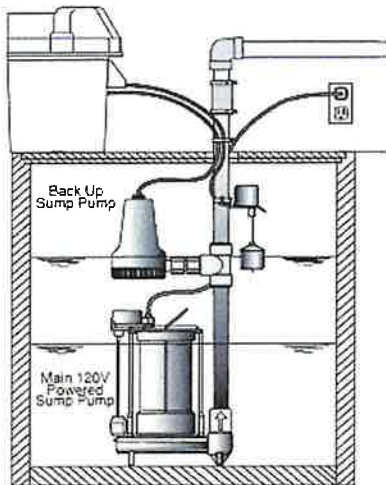
Photo 28-1

28) Comment - No battery backup system was found for the sump pump. If the power goes out during heavy rains, the sump pump won't be able to eliminate accumulated water. Consider installing a battery backup system for the sump pump.

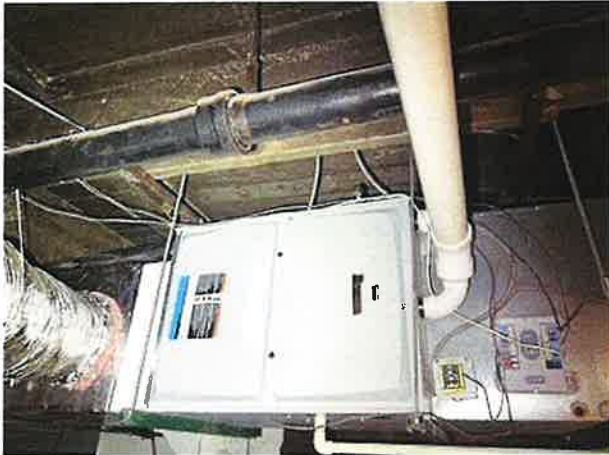
Photo 29-1

29) Repair/Maintain, Evaluate - No indication of any past servicing or it has been too long. Recommend that a qualified HVAC contractor inspect, clean,

and service this system, and make repairs if necessary. For safety reasons, and because this system is fueled by gas or oil, this servicing should be performed annually in the future. Any needed repairs noted in this report should be brought to the attention of the HVAC contractor when it's serviced.

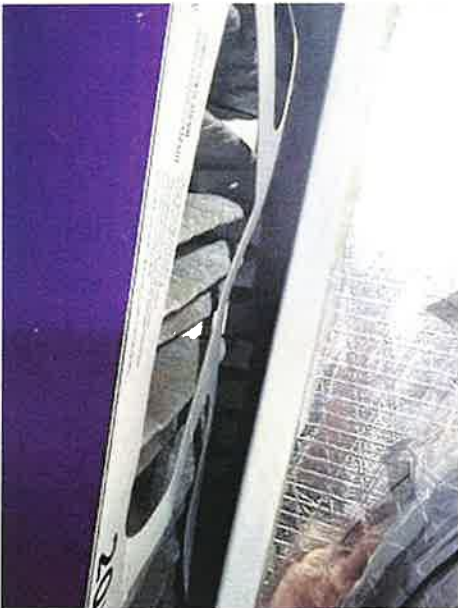
Photo 30-1

30) Maintain - Recommend that home buyers replace or clean HVAC filters upon taking occupancy depending on the type of filters installed. Regardless of the type, recommend checking filters monthly in the future and replacing or cleaning them as necessary. How frequently they need replacing or cleaning depends on the type and quality of the filter, how the system is configured (e.g. always on vs. "Auto"), and on environmental factors (e.g. pets, smoking, frequency of house cleaning, number of occupants, the season).

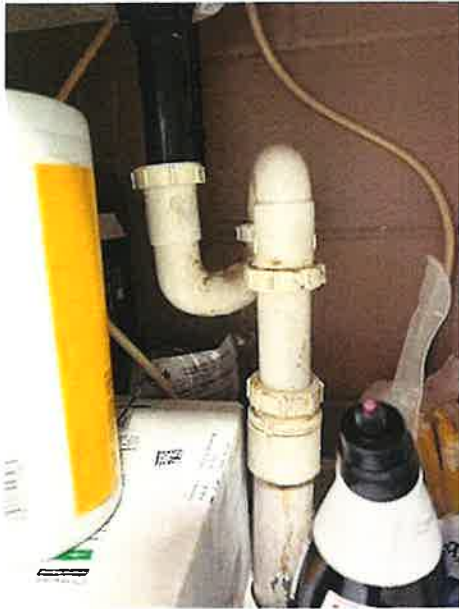
Photo 31-1

31) Repair/Replace - The sink drain pipe at location(s) #A used an S-trap rather than a P-trap, or no P-trap was visible. Siphons and sudden flows of water in S-Traps can drain all the water out of the trap, leaving it dry. Sewer gases can then enter living areas. Recommend that a qualified plumber repair per standard building practices.

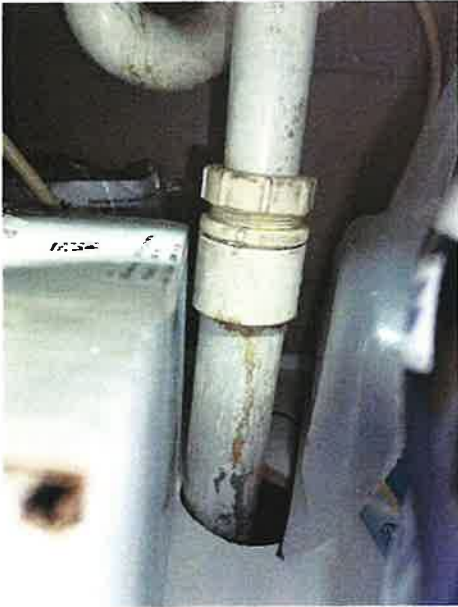
Photo 32-1

32) Repair/Maintain, Evaluate - Evidence of past leaks observed on bathroom sink drain, including staining and residue around fittings. Recommend monitoring for active leaks and addressing with tightening or replacement if necessary.

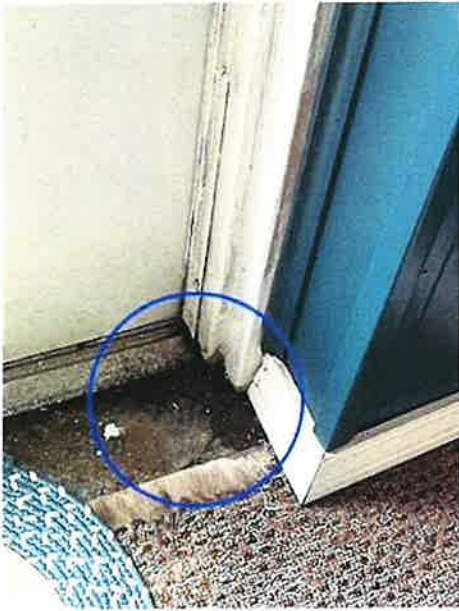
Photo 33-1

33) Repair/Maintain, Monitor - One or more exterior doors had evidence of leaks. A qualified person should evaluate and make repairs as necessary.

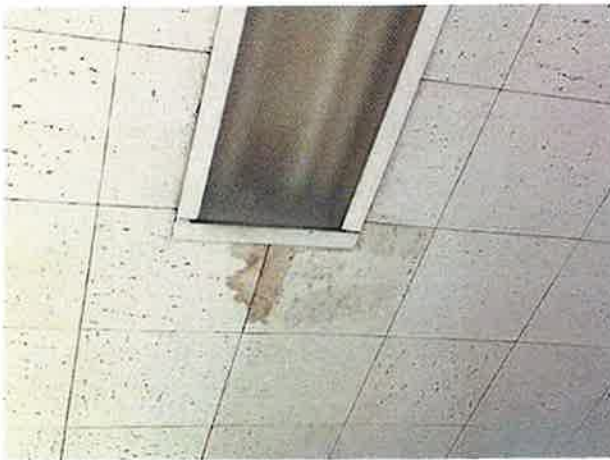
Photo 34-1

34) Monitor - Stains were found in one or more ceiling areas. However, no elevated levels of moisture were found. The stain(s) may be due to past roof and/or plumbing leaks. Consult with the property owner and monitor the stained area(s) in the future, especially after heavy or prolonged rain. If elevated moisture is found in the future, then recommend that a qualified contractor evaluate and repair as necessary.
