THE TOWN OF ALBION

What: REQUEST FOR INFORMAL PROPOSALS (RFP) to PURCHASE REAL PROPERTY

Where: Town-owned building located at 110 S. Orange Street, Albion IN 46701

Property Inspection Report

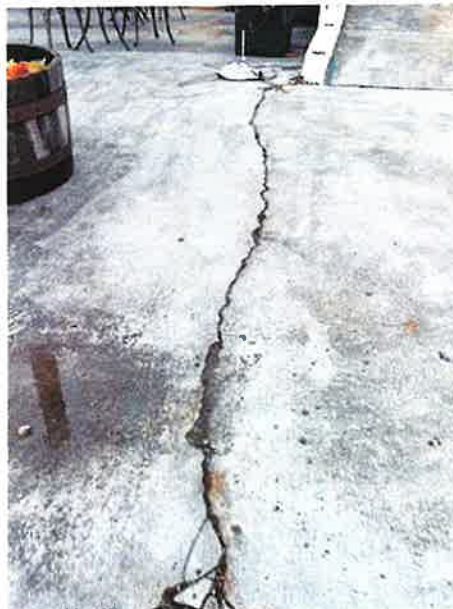
Photo 3-2

3) Repair/Maintain - Cracks, holes, settlement, heaving and/or deterioration were found in sidewalks and/or patios. Recommend that qualified contractor repair as necessary.

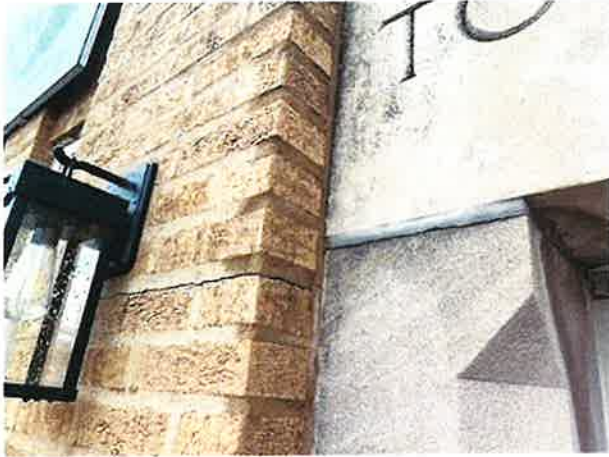
Photo 4-3

4) Repair/Replace, Evaluate - The masonry (brick or stone) veneer was deteriorated or damaged in many areas. Where cracks or openings are exposed, water may enter the wall structure causing mold, fungal growth and structural damage. This is a conducive condition for wood-destroying organisms. Recommend that a qualified contractor repair as necessary. For example, by repointing mortar or replacing broken or missing masonry.

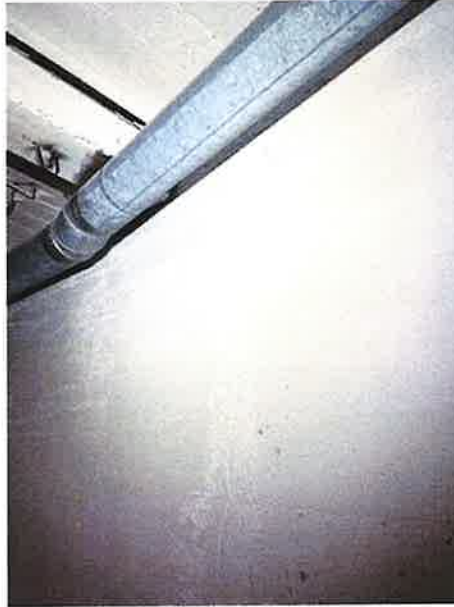
Photo 8-2

8) Evaluate - Any past repairs or patching to the foundation walls should be disclosed to the buyer. These repairs could indicate previous issues with moisture intrusion, structural concerns, or other conditions that warranted corrective action. Proper disclosure allows the buyer to assess the quality and extent of repairs and to consider any potential need for future maintenance or monitoring

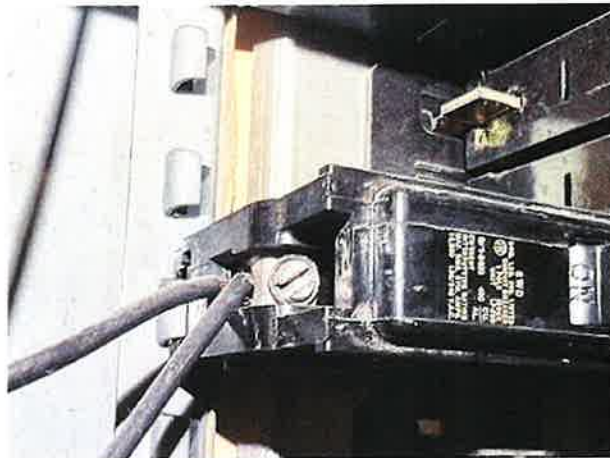
Photo 16-2

Many breakers do not allow two wires per connection (double tap). Two wires of different wire gauge sizes (diameter) should never be used.
